OPERATION PLUMBBOB

NEVADA TEST SITE
MAY-OCTOBER 1957

Project 30.7

TEST OF GERMAN UNDERGROUND
PERSONNEL SHELTERS

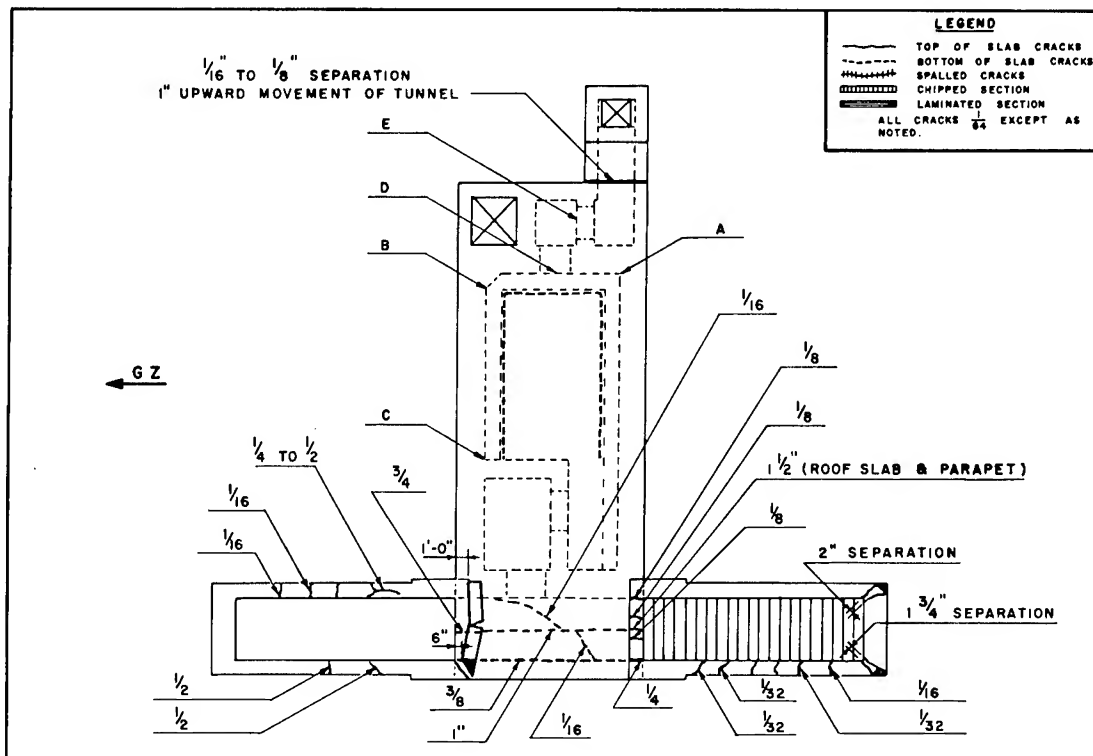
(c) *Main Chamber*. Hairline cracks were formed at the intersection of the roof slab and the haunches along the rear and side walls of the main chamber. The intersection of the walls located at points A, B, and C of Fig. 3.1 had continuous hairline cracks the full height of the walls. Diagonal hairline cracks were formed at the four corners of the door opening located at point D. Numerous transverse and longitudinal hairline cracks were produced on the floor slab of the main chamber. No cracks were present in the floor slab of the main chamber adjacent to the main seal door.

(d) *Exit Chamber*. As in the main chamber, diagonal cracks were formed at the four corners of the door opening located at point E, Fig. 3.1. No structural damage was evident in the roof and floor slabs.

Fig. 3.1—Roof-slab crack pattern (structure RAa).

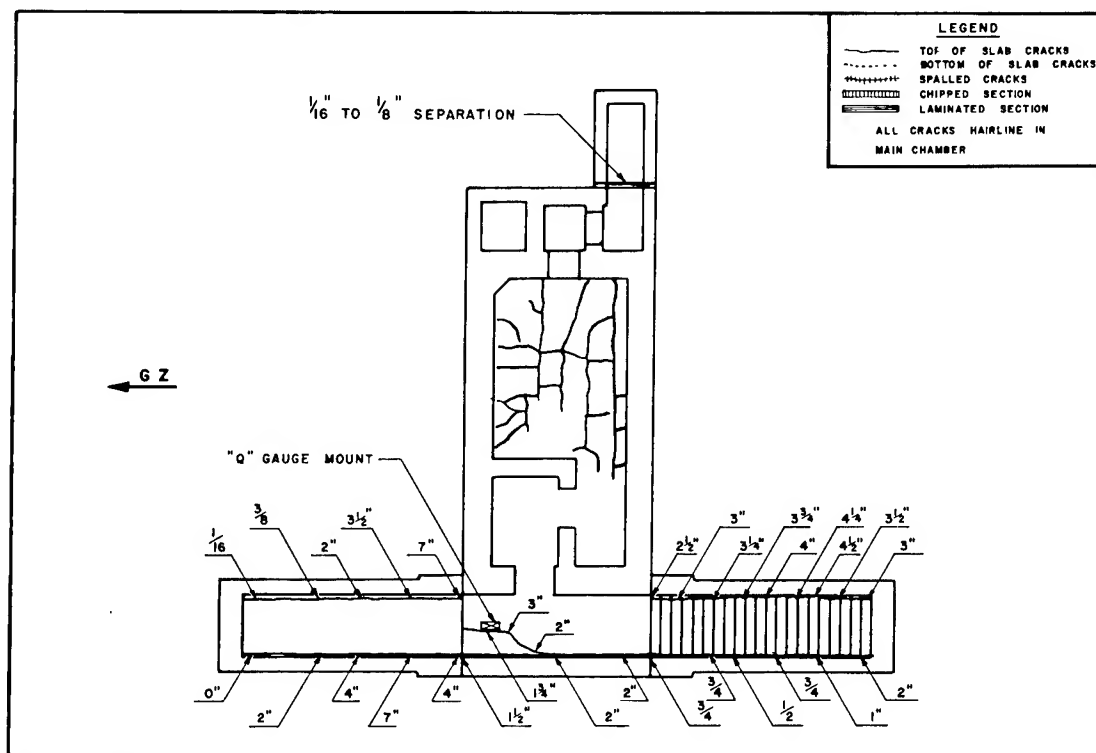
Fig. 3.2—Floor-slab crack pattern (structure RAa).

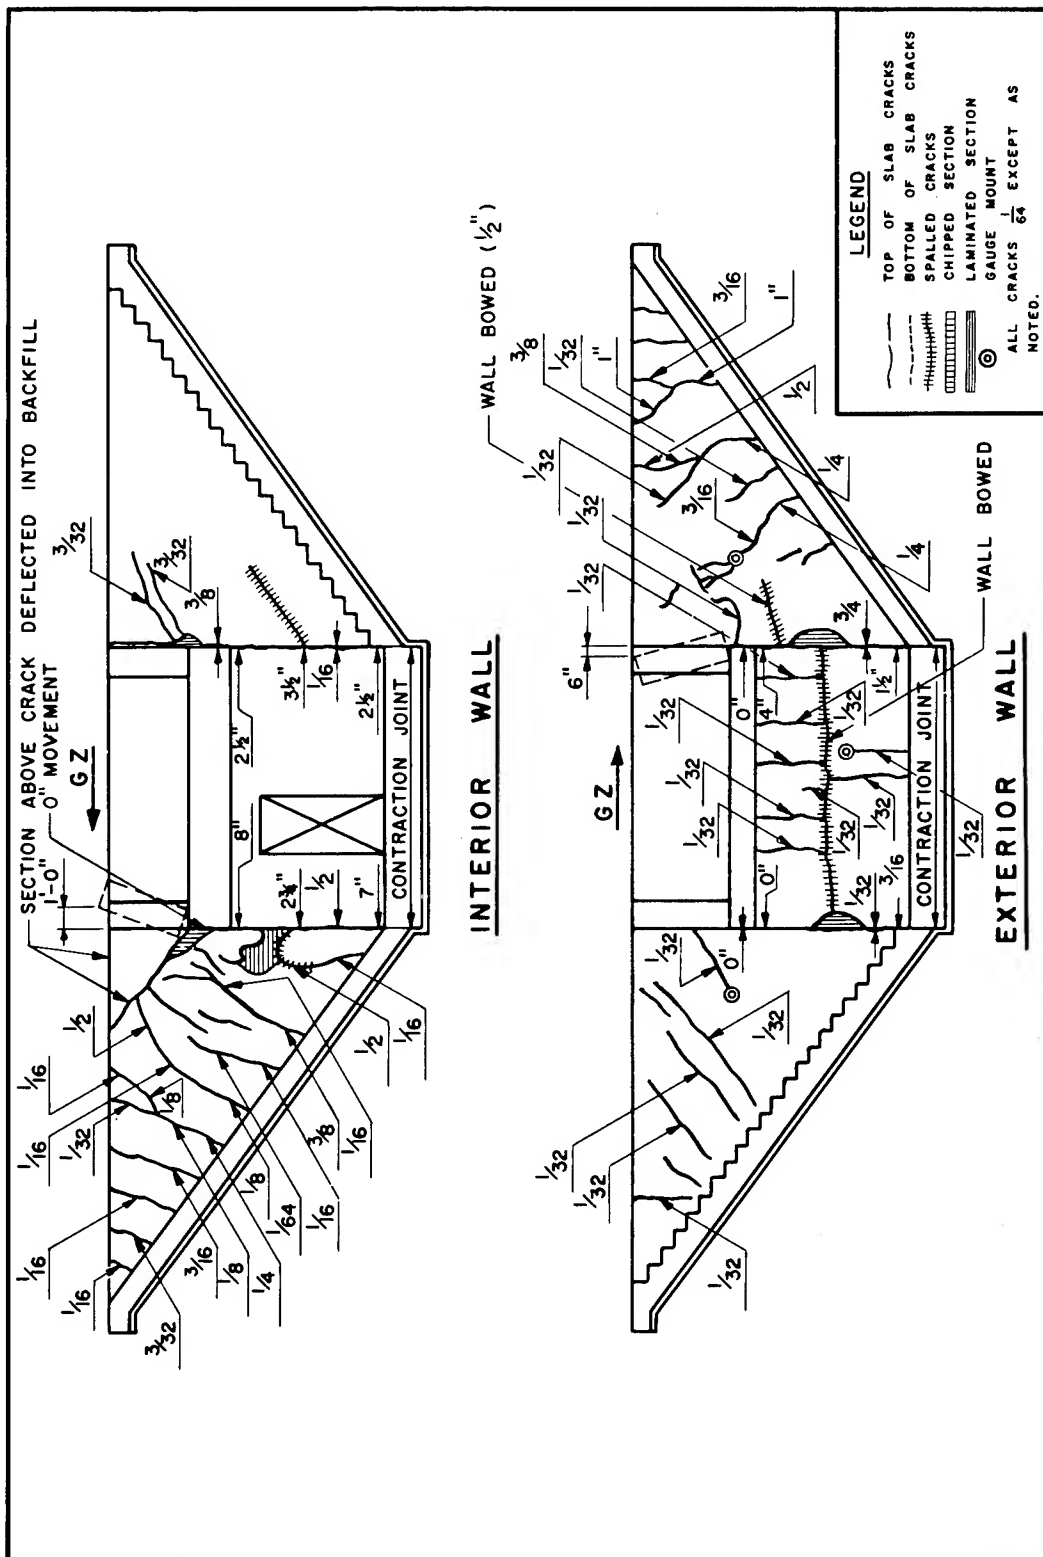
(a) *Entranceways.* In the ramp entrance facing GZ separations formed at the intersections of the interior and exterior walls with the ramp slab. The interior wall was pulled away from the slab 7 in. at the bottom and $\frac{1}{16}$ in. at the top of the ramp. The intersection of the ramp and exterior wall was similar to that at the interior wall; that is, the crack varied from 4 to 7 in. near the bottom to zero inches at the top of the ramp. Bowing of the interior wall into the backfill was produced at the quarter-height along the contraction joint. A $\frac{1}{16}$ - to $\frac{1}{2}$ -in. vertical crack was formed near the bottom of the ramp. This crack terminated at a laminated area located at the mid-height of the wall. There was spalling on both sides at the upper section of the crack. Cracks varying from $\frac{1}{16}$ to $\frac{3}{8}$ in. in width, perpendicular to the plane of the ramp, were located approximately 2 ft on center along the length of the wall. The majority of these cracks ran the full height of the wall. A crack starting at a chipped-out section located at the intersection of the end of the roof slab and the interior wall ran diagonally toward the top of the wall. The section of the wall above this crack was deflected back into the fill. The exterior wall damage was similar to that described for the interior wall. A chipped section of the exterior ramp wall was located approximately 4 ft above the landing at the contraction joint. A horizontal crack, with spalling on both sides, above this section produced a $\frac{1}{2}$ -in. bow in this wall. There were numerous diagonal cracks perpendicular to the plane of the ramp located approximately 2 to 3 ft on center in the upper two-thirds of wall. These cracks varied in size from $\frac{1}{32}$ to 1 in. in width. The top of the parapet located above the landing roof slab that faces GZ was deflected into the backfill 6 in. at the intersection of the exterior wall and 1 ft at the interior wall. The corners of the parapet and side walls were chipped, and the reinforcement was exposed.

Fig. 3.3—Entrance crack pattern (structure RAa).

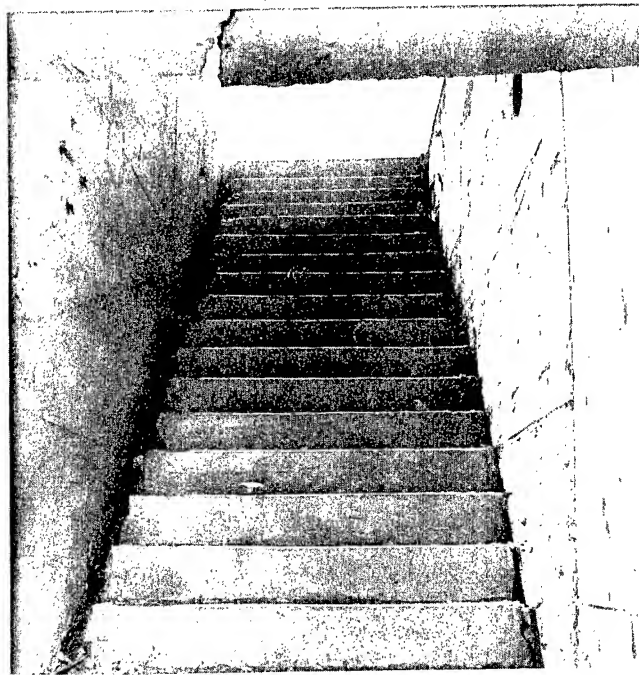
Fig. 3.10—Looking up stairs away from GZ (structure RAa).

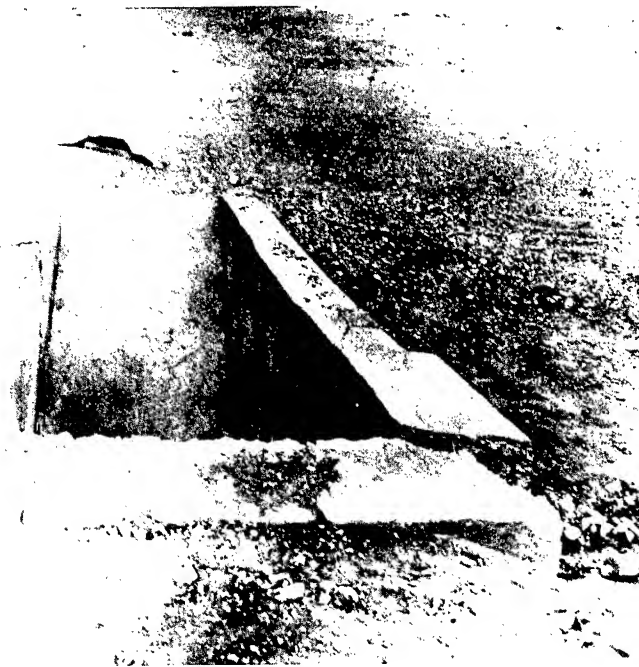
Fig. 3.13—Blast damage to ramp walls of entrance facing GZ (structure RAa).

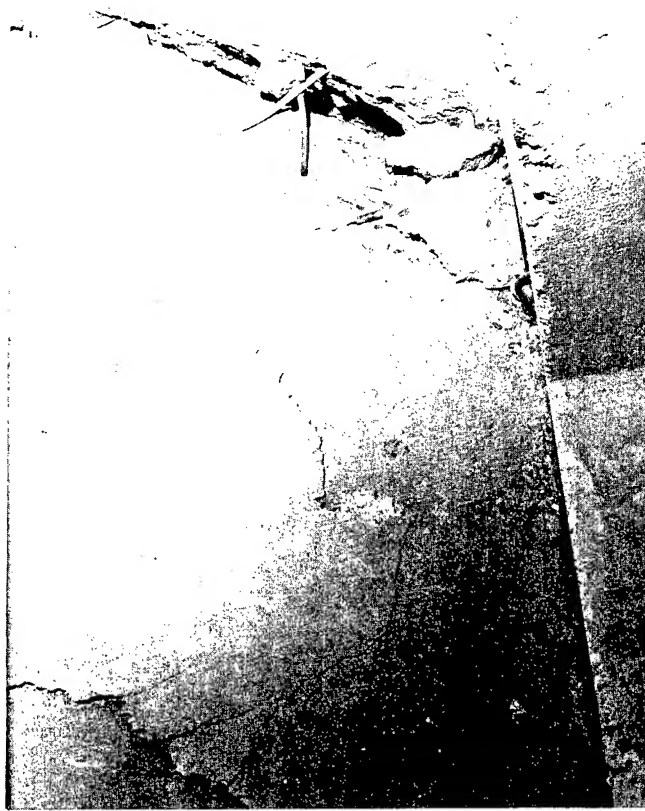
Fig. 3.16—Detail of cracks and spalled and laminated area in interior wall at contraction joint at entrance facing toward GZ (structure RAa).

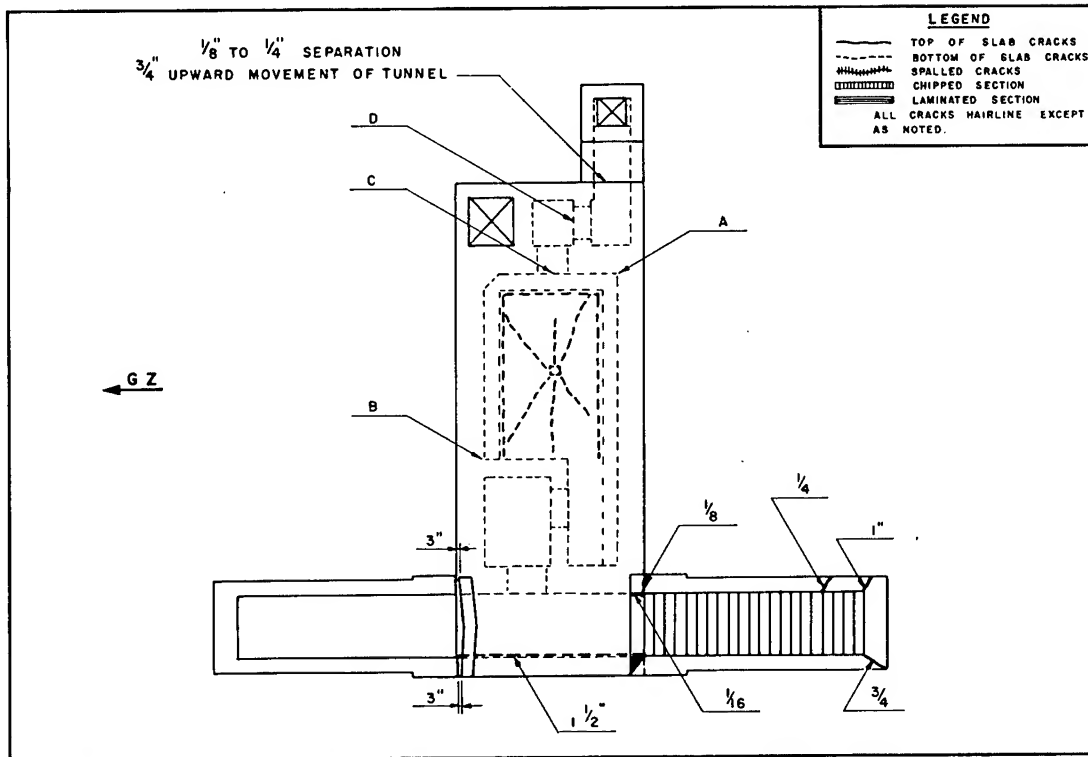
Fig. 3.25—Roof-slab crack pattern (structure RAb).

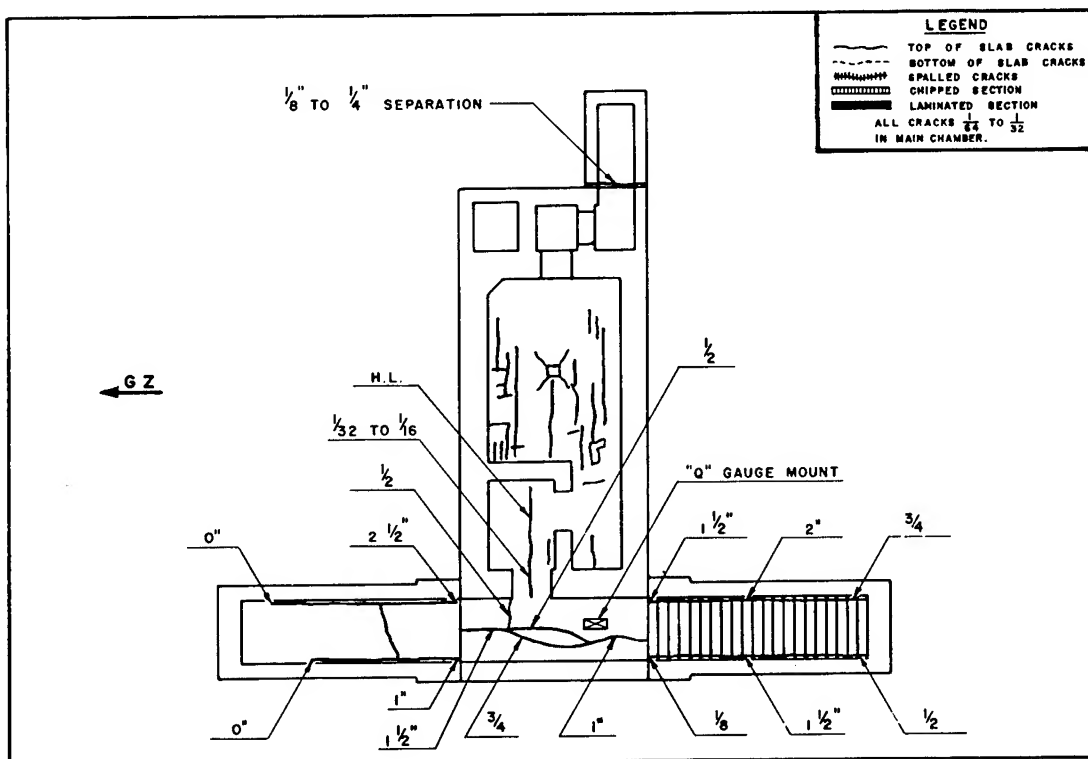
Fig. 3.26—Floor-slab crack pattern (structure RAb).

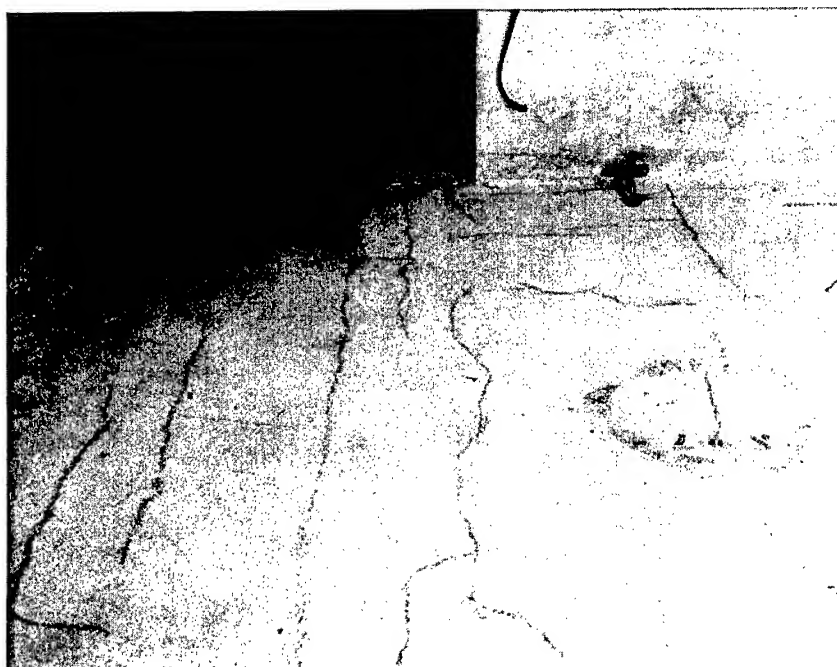
Fig. 3.28—Cracks in floor slab of main chamber, looking toward main entrance (structure RAb).

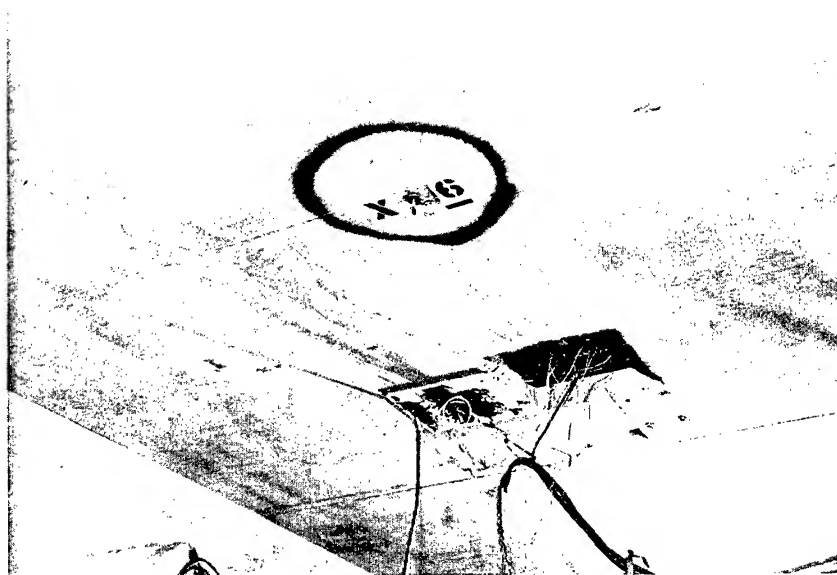
Fig. 3.29—Cracks, strain-gauge recess, and survey point in roof slab of main chamber (structure RAb).

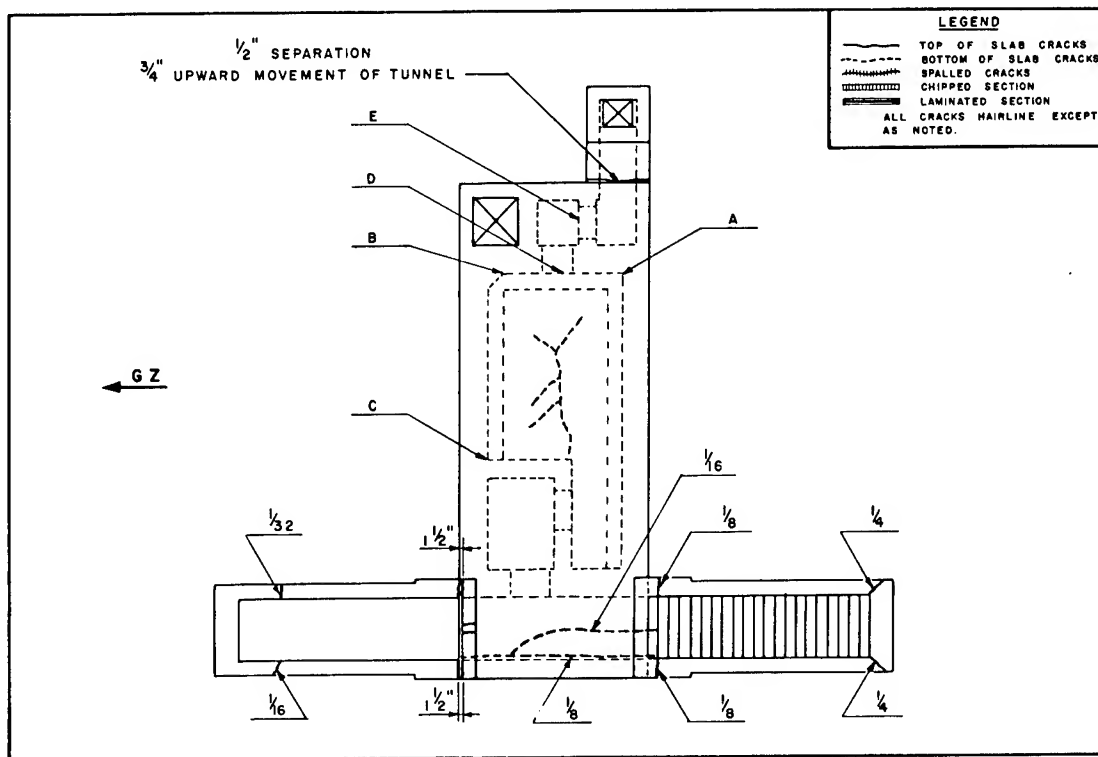
Fig. 3.33—Roof-slab crack pattern (structure RAc).

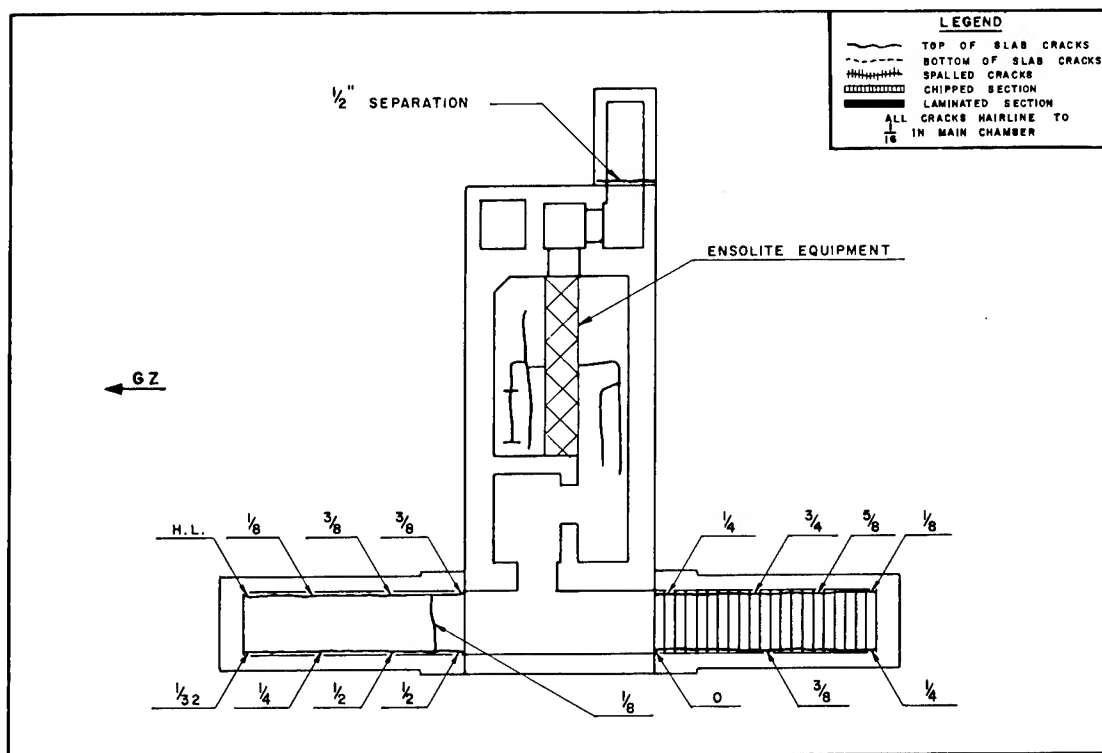
Fig. 3.34—Floor-slab crack pattern (structure RAc).

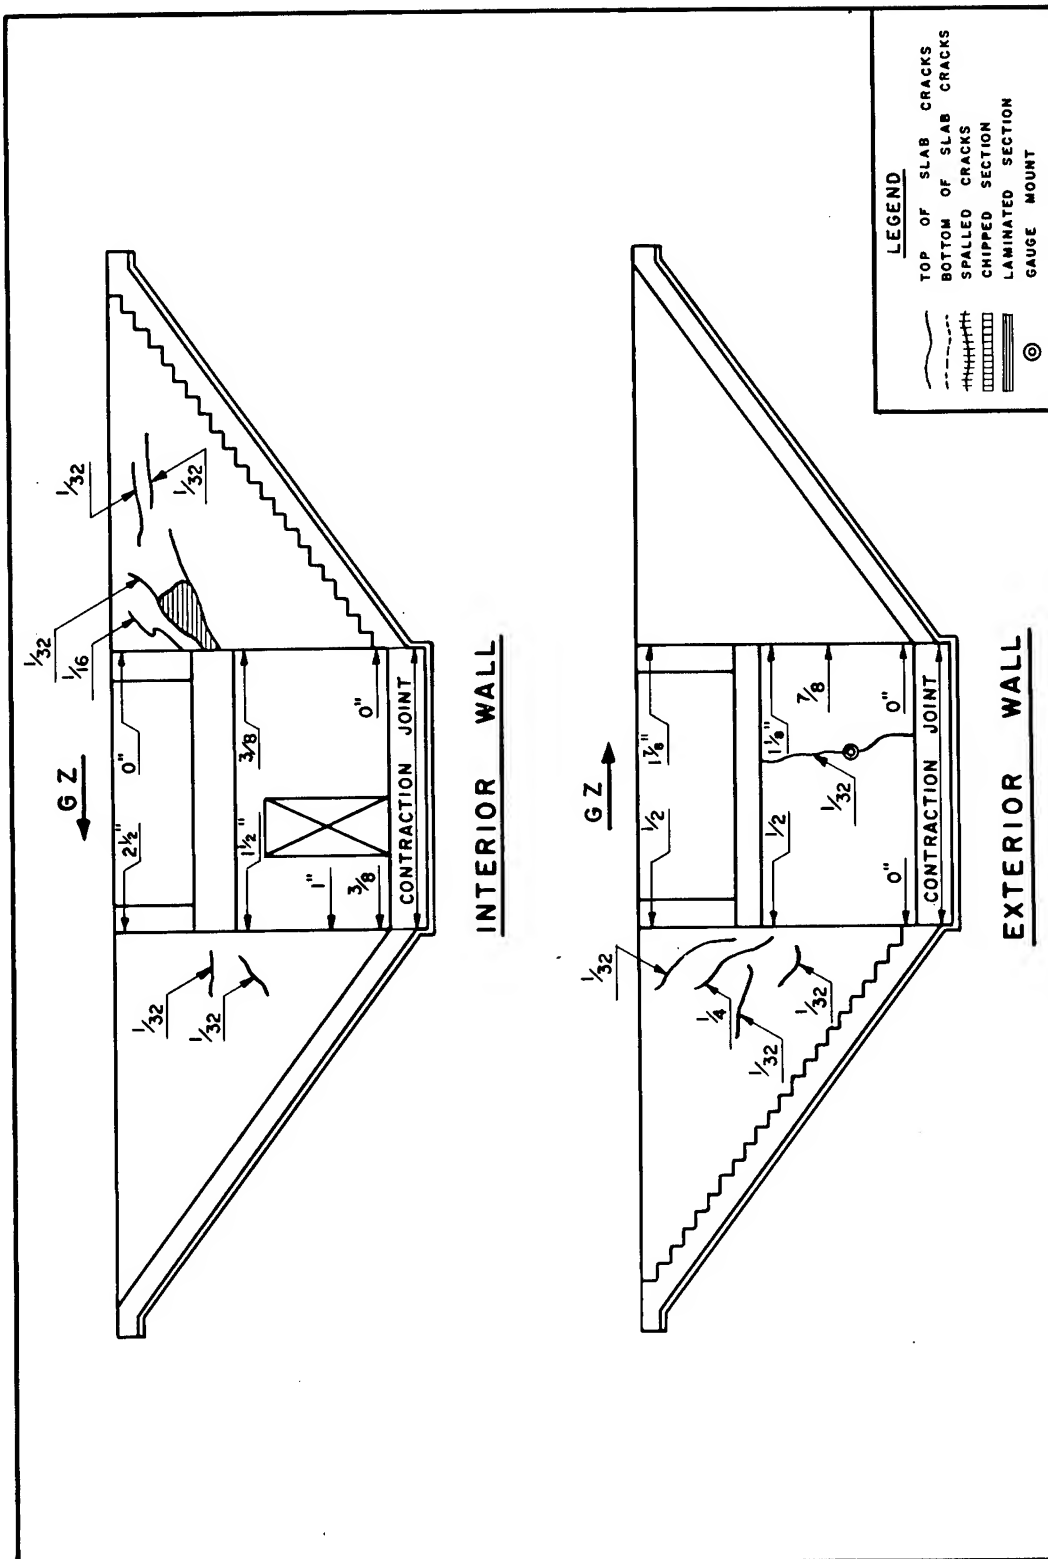
Fig. 3.35—Entrance crack pattern (structure RAc).

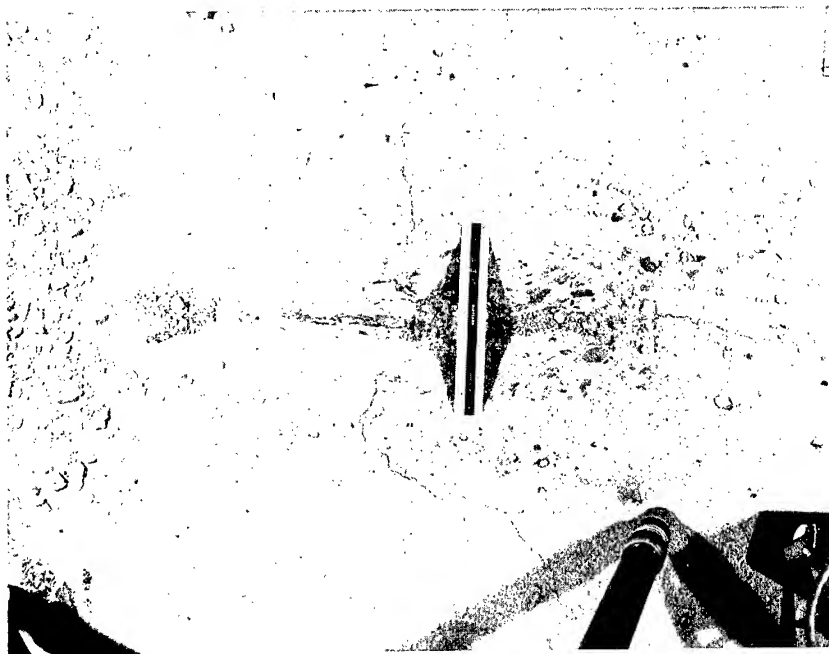
Fig. 3.38—Over-all view of chipped-out section with associated crack pattern (structure RAc).

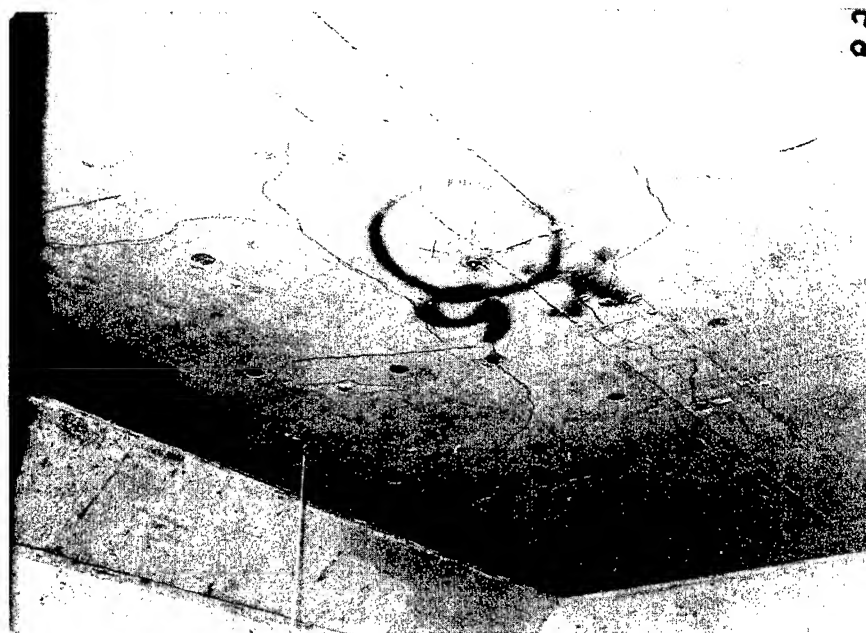
Fig. 3.43—Cracks in roof slab of main chamber (structure RAc).

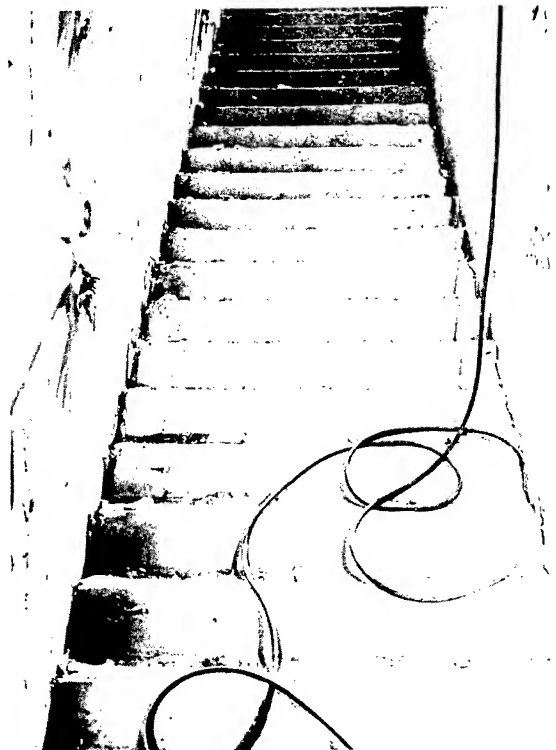
Fig. 3.46—Looking up stairs facing away from GZ, showing separations between stairs and interior and entrance walls (structure RAc).

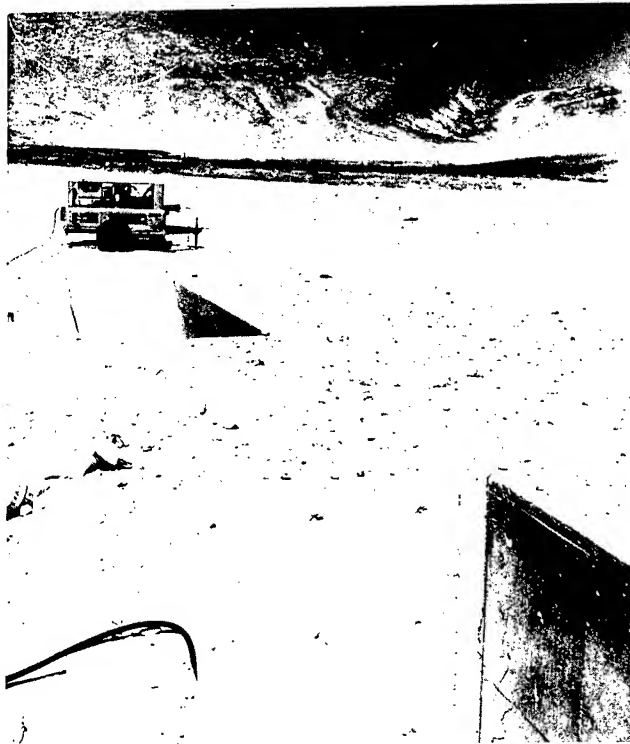
Fig. 3.48—Detail of cracks at intersection of parapet wall and interior wall and entrance facing away from GZ (structure RAc).

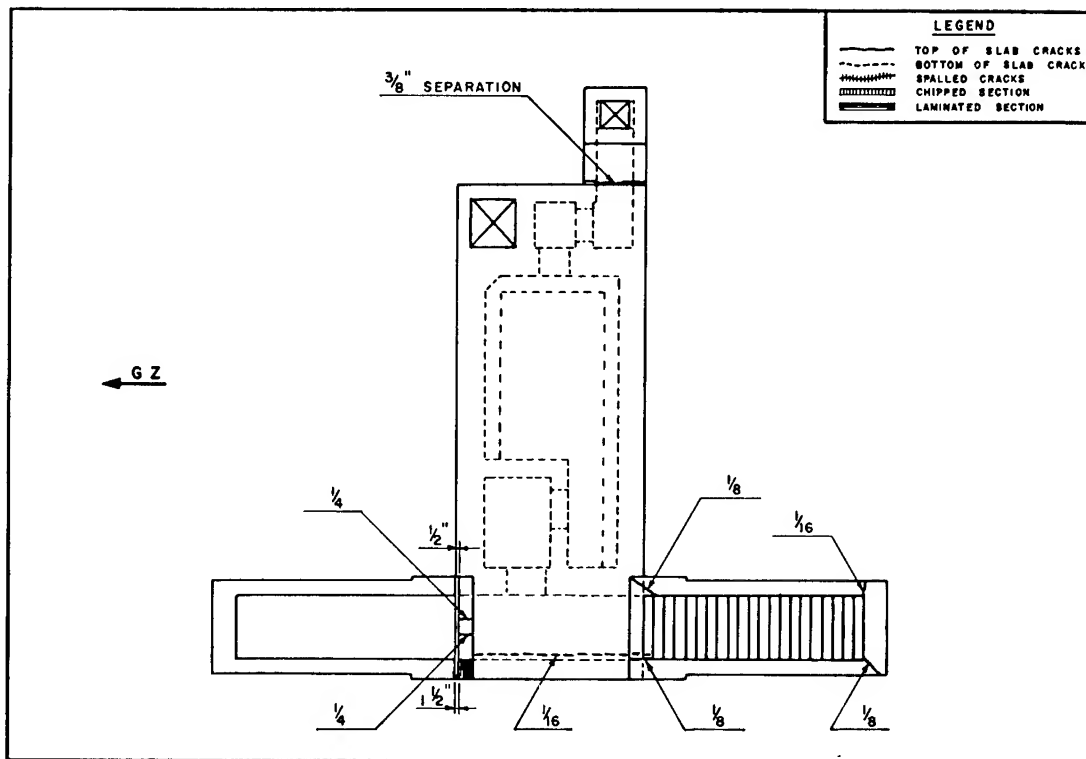
Fig. 3.54—Roof-slab crack pattern (structure RAd).

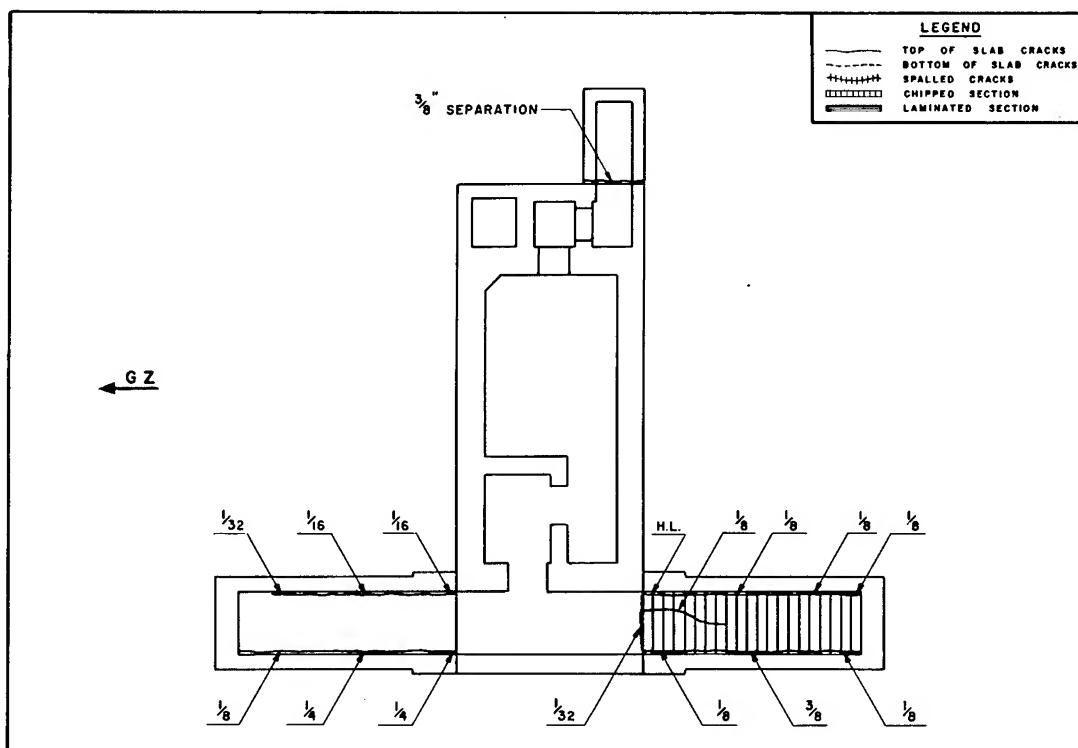
Fig. 3.55—Floor-slab crack pattern (structure RAd).

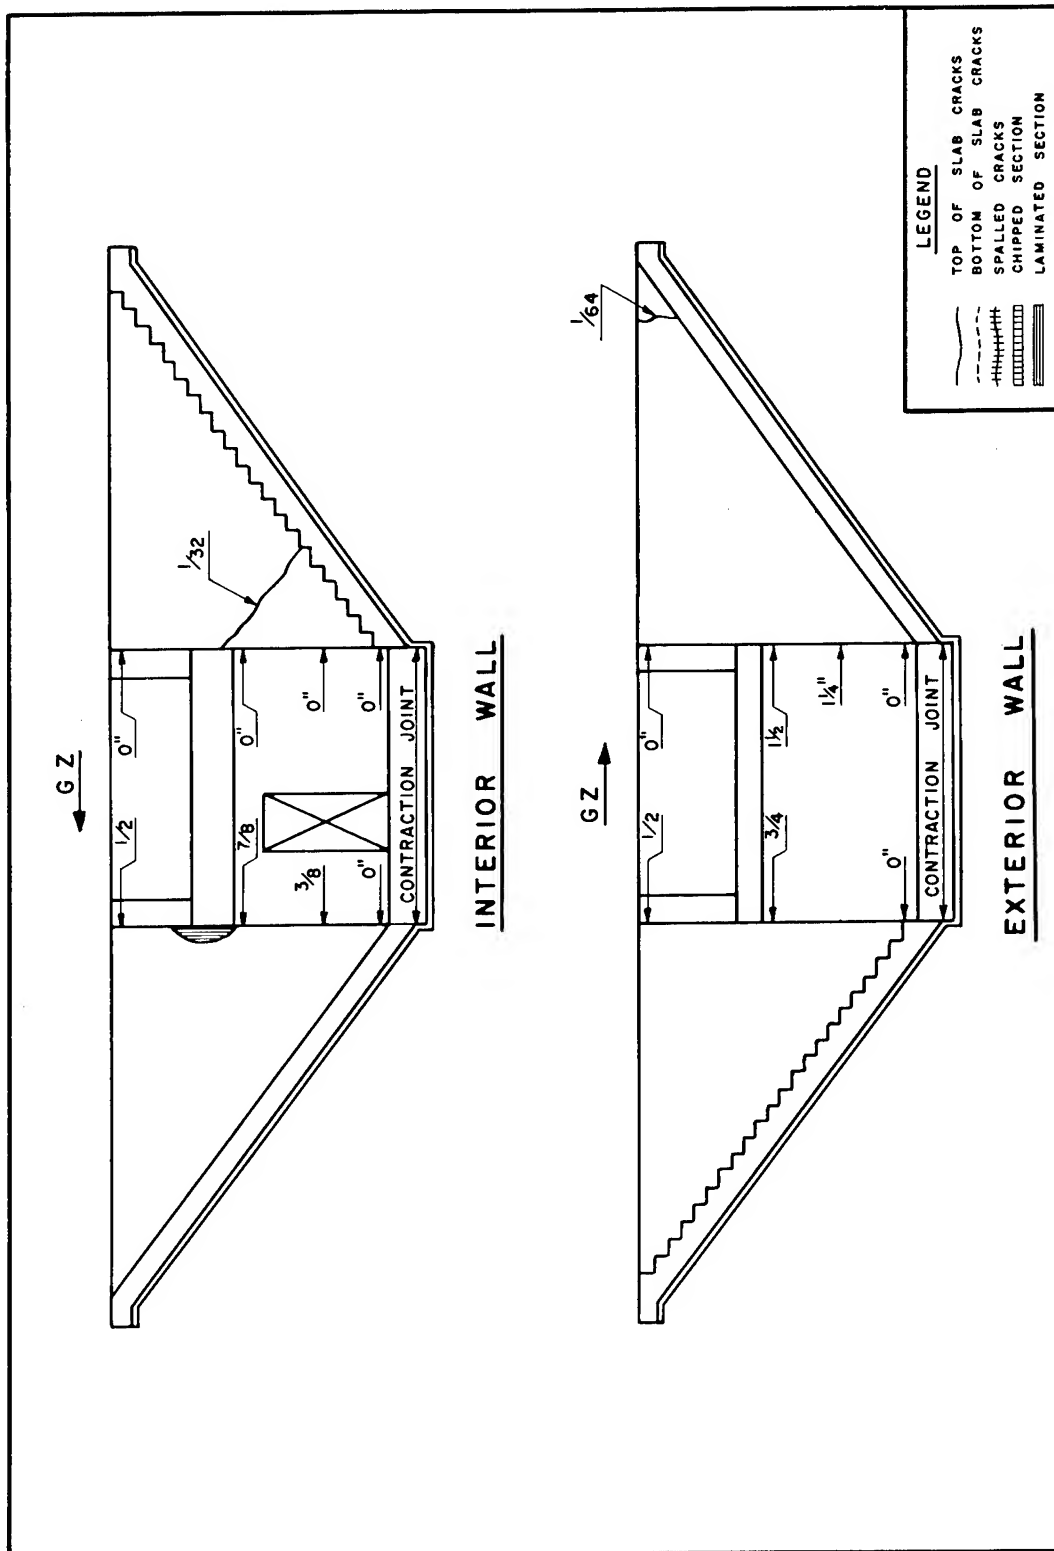
Fig. 3.56—Entrance crack pattern (structure RAD).

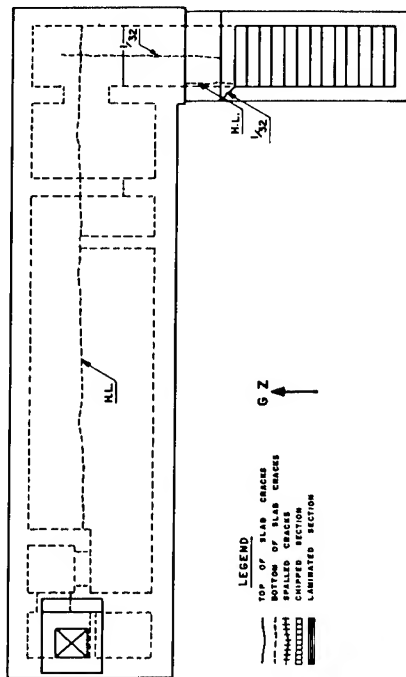
Fig. 3.58—Roof-slab crack pattern (structure CAa).

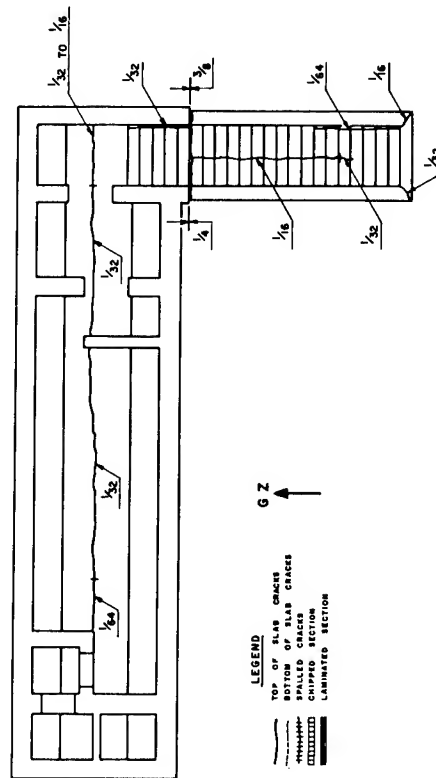
Fig. 3.59—Floor-slab crack pattern (structure CAa).

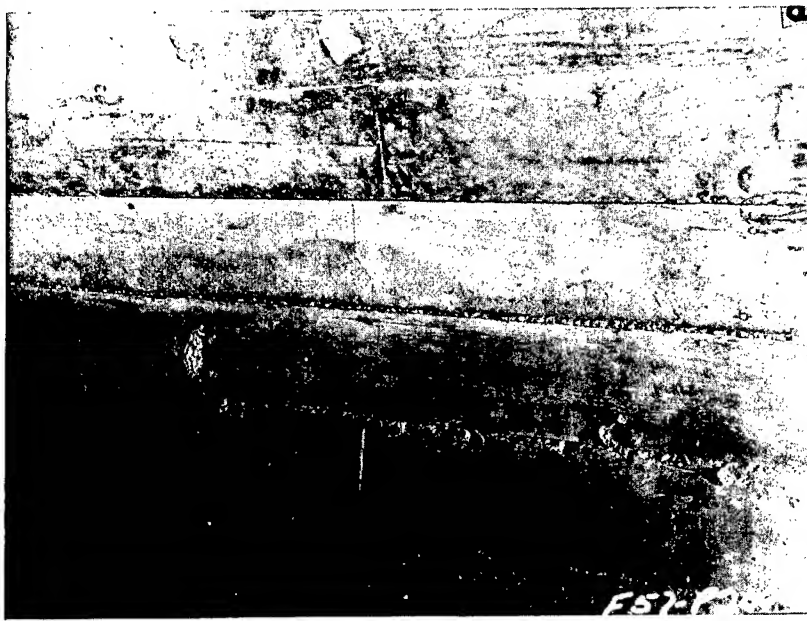
Fig. 3.64—Crack in the main chamber at approximately the center of the side facing toward GZ (structure CAa).

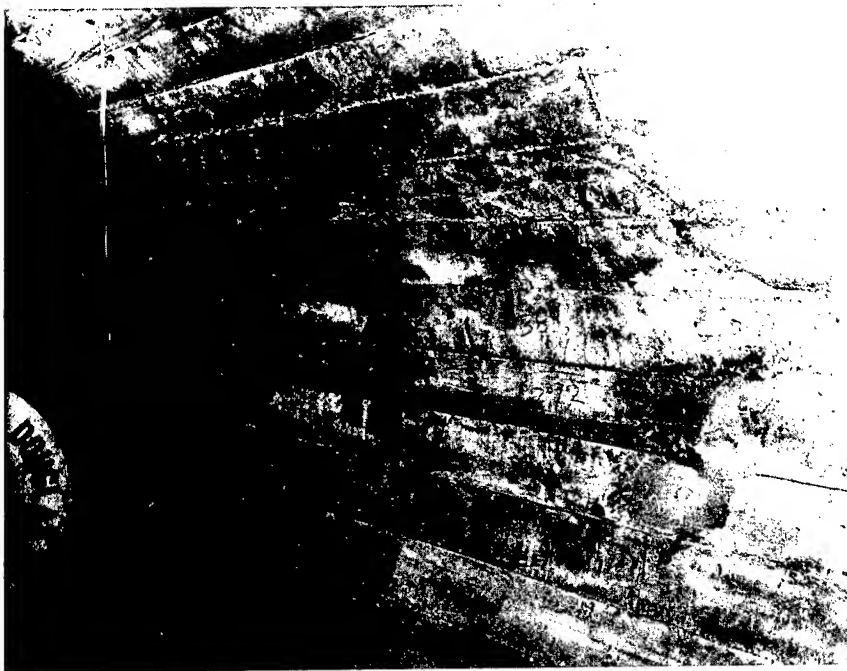
Fig. 3.76—Side of main chamber facing toward GZ (structure CAb). Note cracks by survey point X-4 and horizontal cold joint.

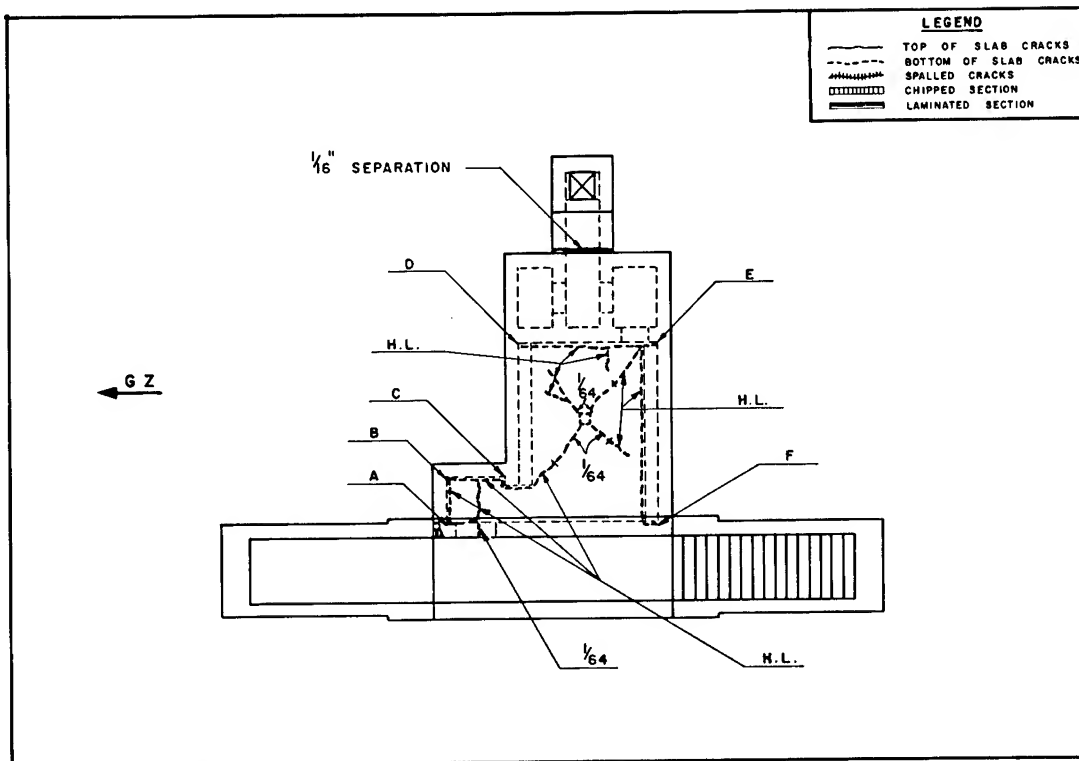
Fig. 3.82—Roof-slab crack pattern (structure RCa).

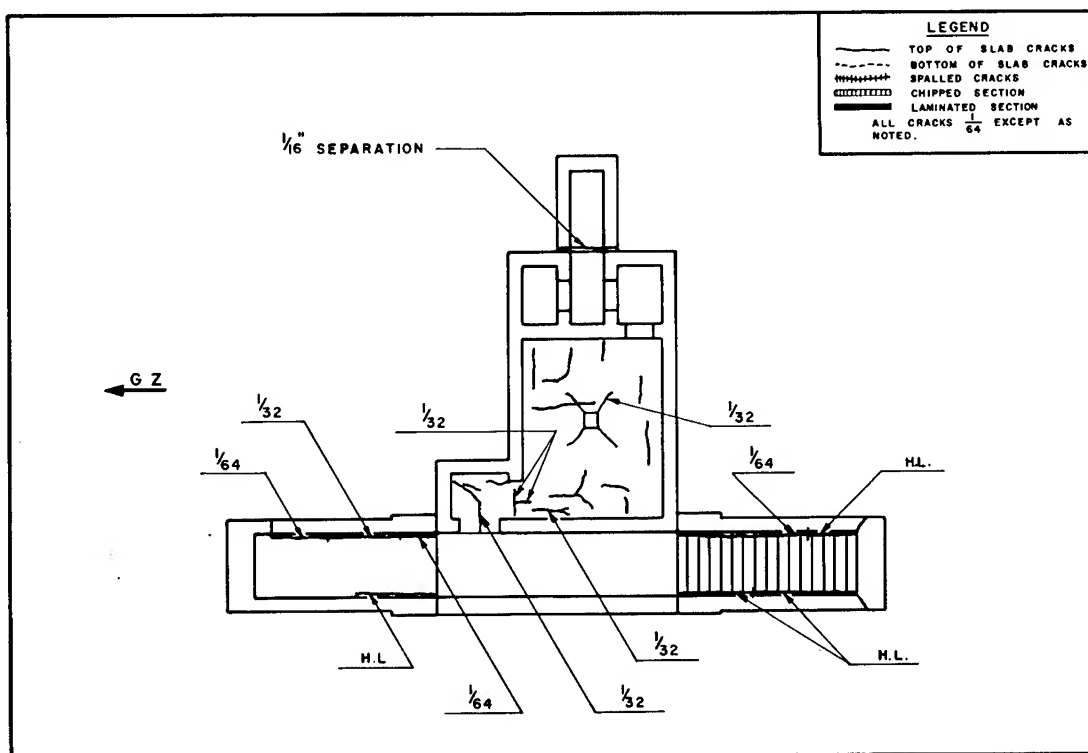
Fig. 3.83—Floor-slab crack pattern (structure RCa).

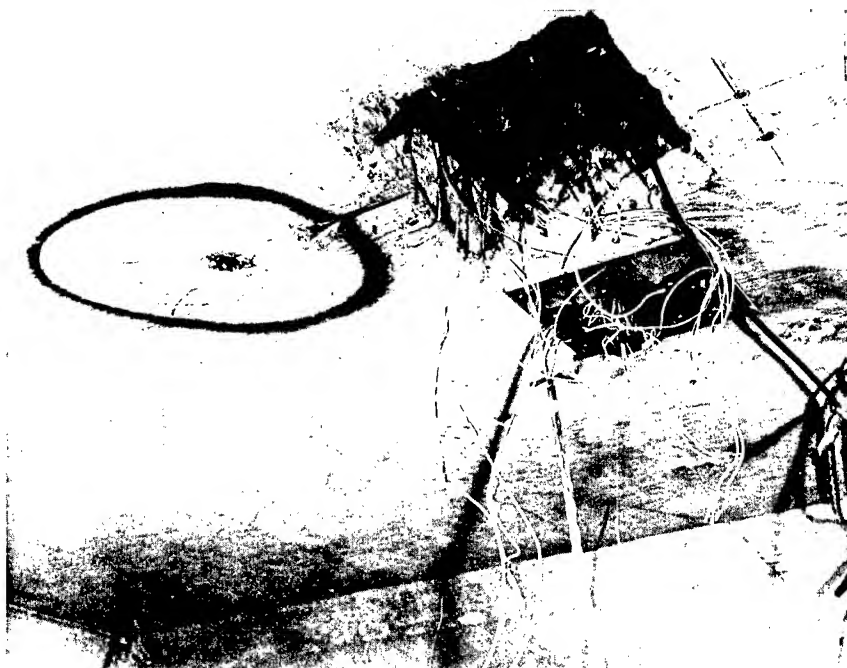
Fig. 3.86—Cracks in roof slab of main chamber, looking toward emergency-exit end of wall facing away from GZ (structure RCa).

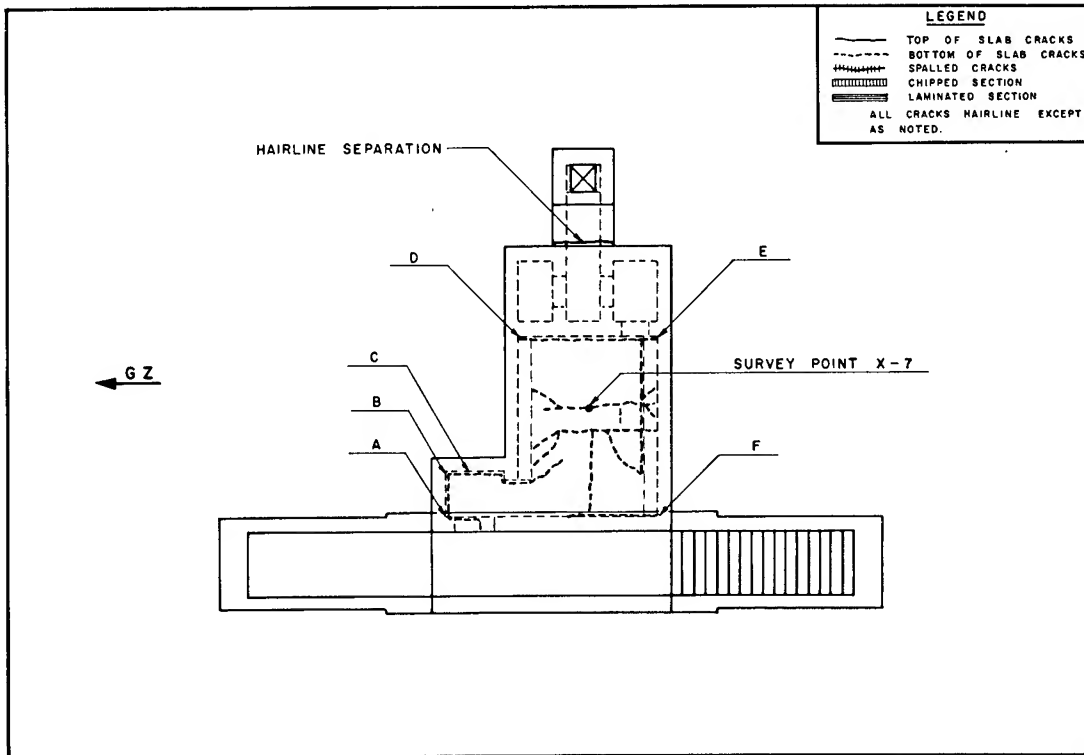
Fig. 3.92—Roof-slab crack pattern (structure RCb).

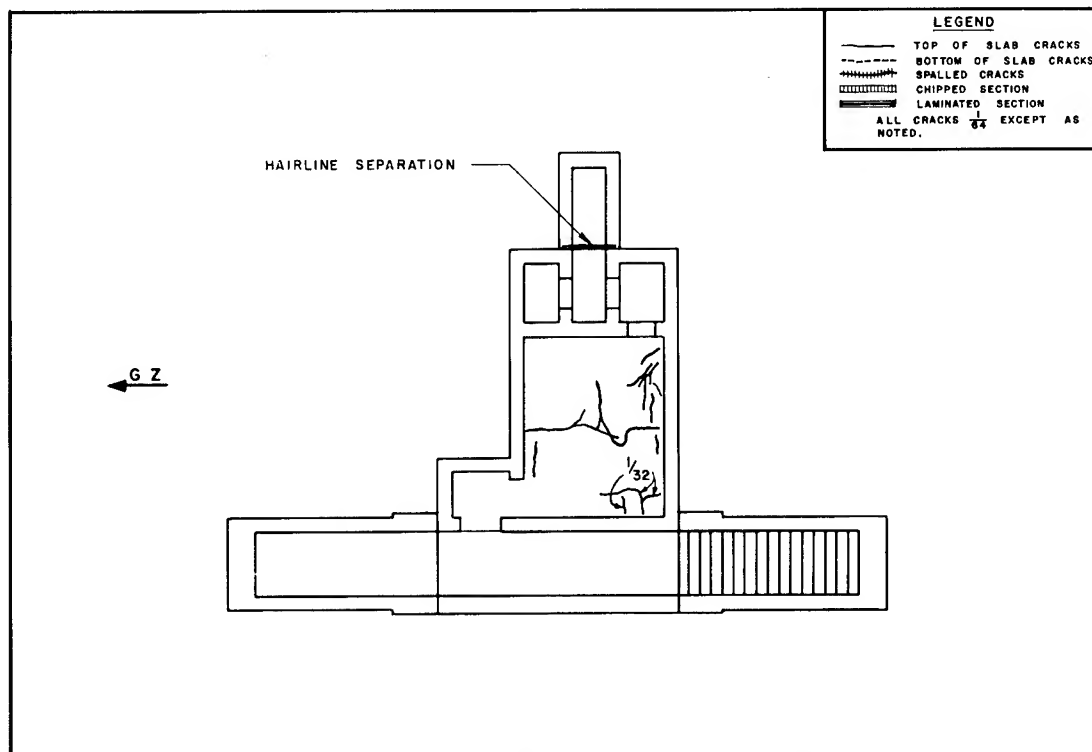
Fig. 3.93—Floor-slab crack pattern (structure RCb).
